INSPECTION REPORT

CRYSTAL LAKE DAM CT DEEP #08301

PROUT HILL ROAD
PROUT BROOK
MIDDLETOWN, CONNECTICUT

FEBRUARY 2017

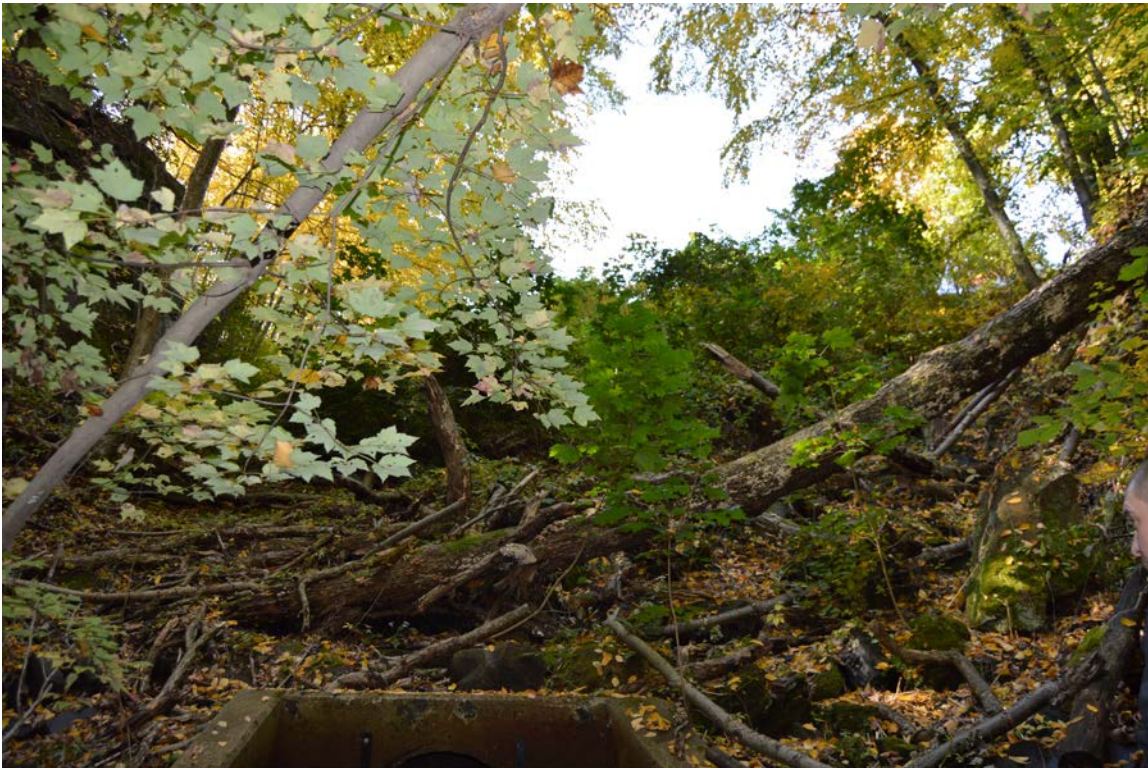
Photo 2a – An overview of the dam taken on October 18, 2016 from the downstream toe area, just beyond the low level outlet discharge.

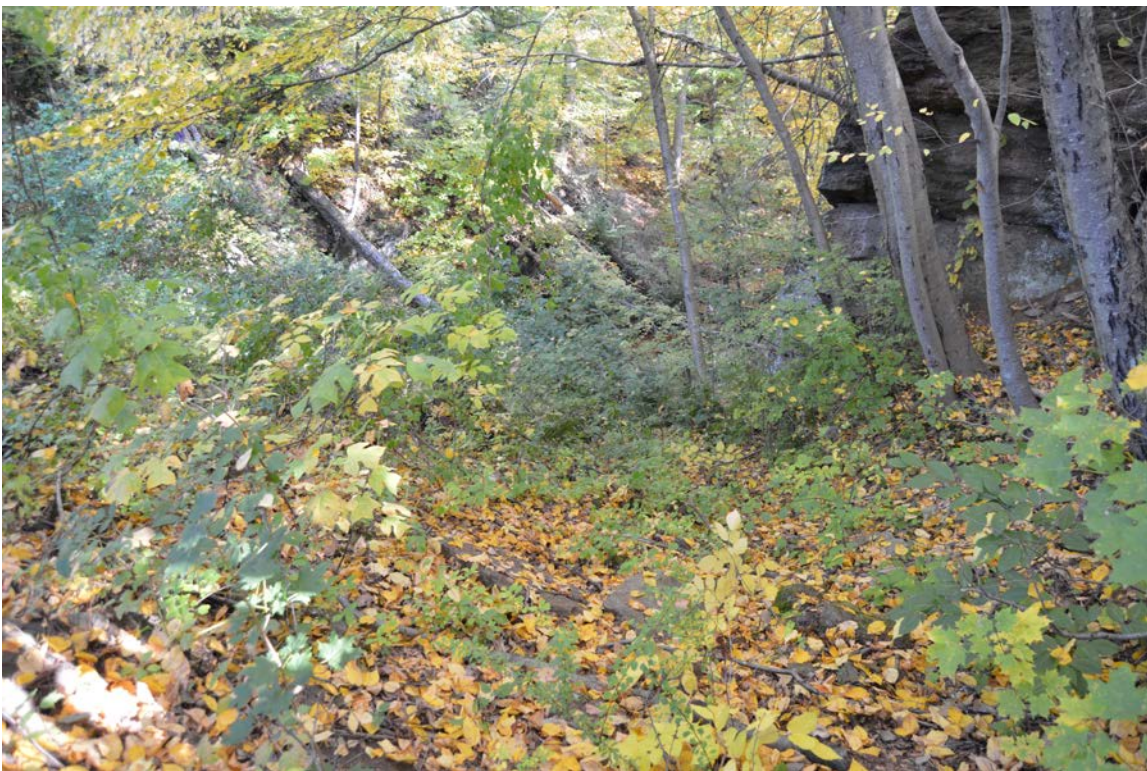
Vegetative Cover: As noted above, the vegetative cover on the downstream slope consists of weeds, brush, woody vegetation and small trees, covering almost the entire embankment. During the growing season, this vegetation can easily reach 6 to 8 feet in height, and the extent of the growth prevents observation of the underlying embankment condition from the crest or toe areas, except that portions can be seen during the non-growing season from the toe. This vegetation has been cut inconsistently in the past, and is difficult to maintain as cutting (even prior to growth of trees and woody vegetation) must be done with hand-held equipment. The grass cover on the crest of the dam is regularly maintained and generally in good condition. The grass areas of the upstream slope are, likewise, in generally good condition, with the riprap set at or near ground level, so that grass between the stones can be more easily maintained.

Photo 7a – Although badly obscured by tree and brush growth, this view is of the right side of the downstream embankment, as seen from the crest of the dam. The edge of the embankment is approximately where the large bedrock stone juts out in the right side of the photo.

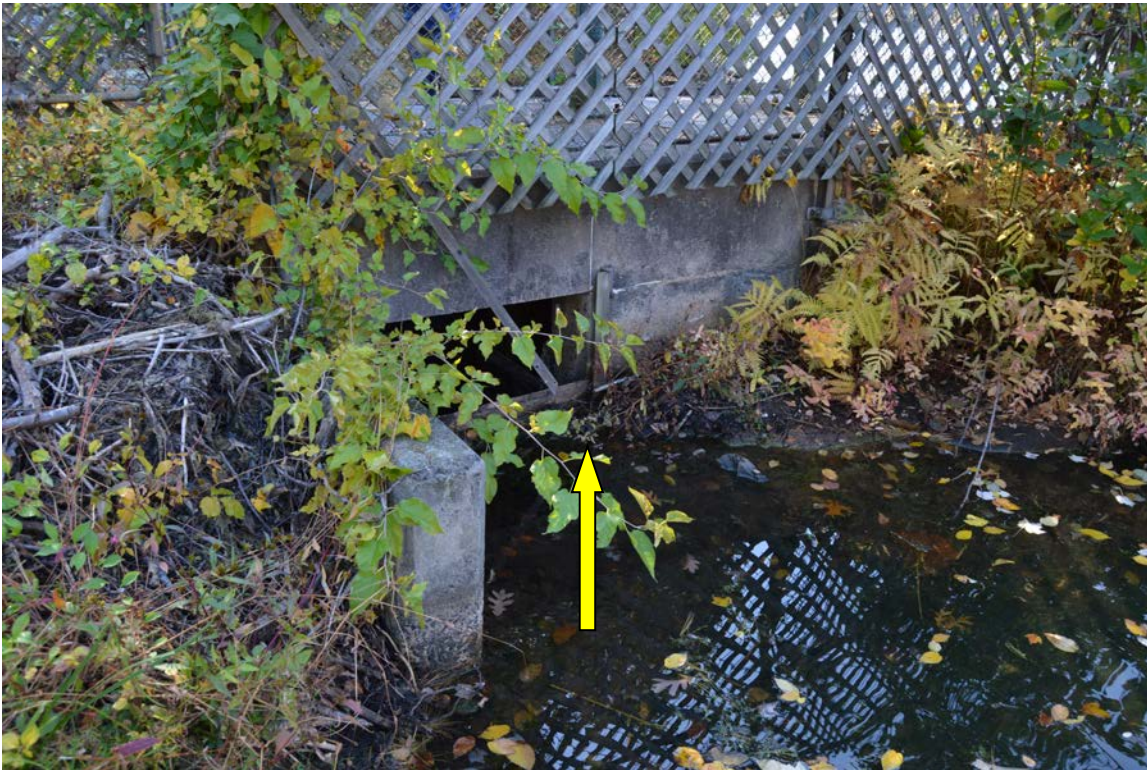
General Condition: Fair. There is brush growing in front of and near the spillway opening, which must be cut before it matures further.

Photo 9a – Looking southward at the entrance to the drop inlet weir. Brush and vine growth is clearly visible. The arrow points to the inlet; weir boards were in place on the date of inspection.

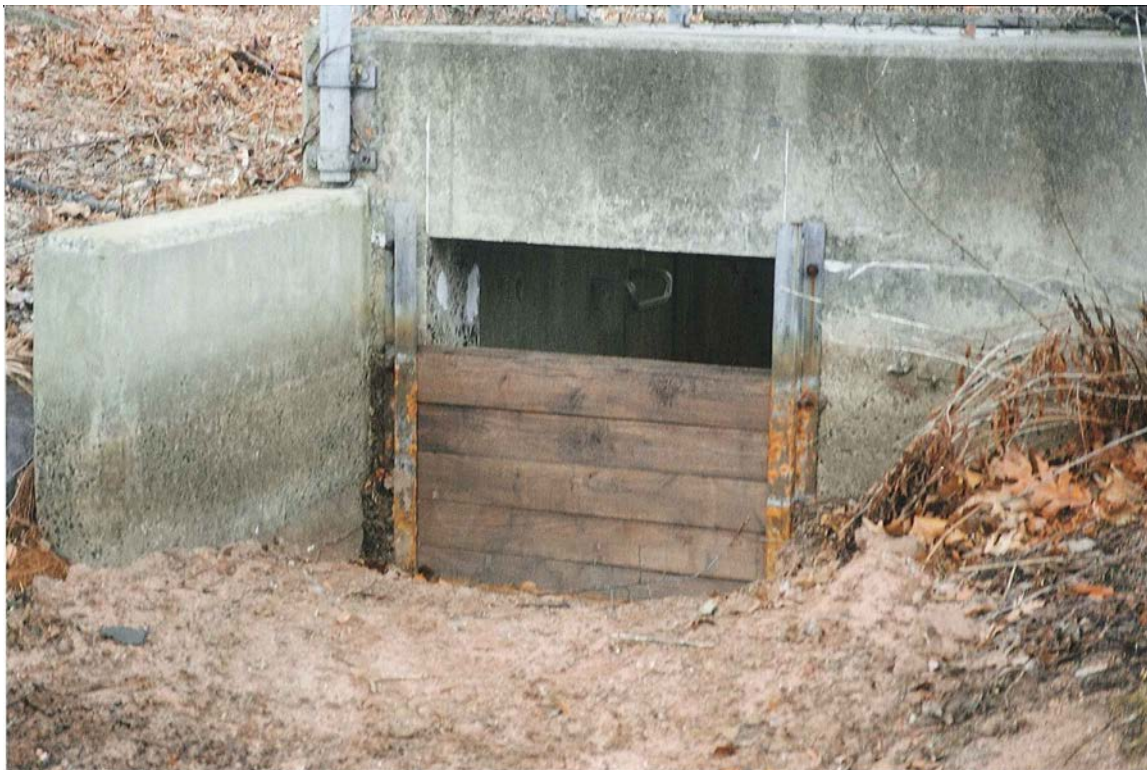
Photo 9b – A view of the spillway inlet area, with brush and vegetative growth cleared and weir boards in place, taken in March 1996. Note the corrosion on the steel frame channels, which had been installed only six years earlier.

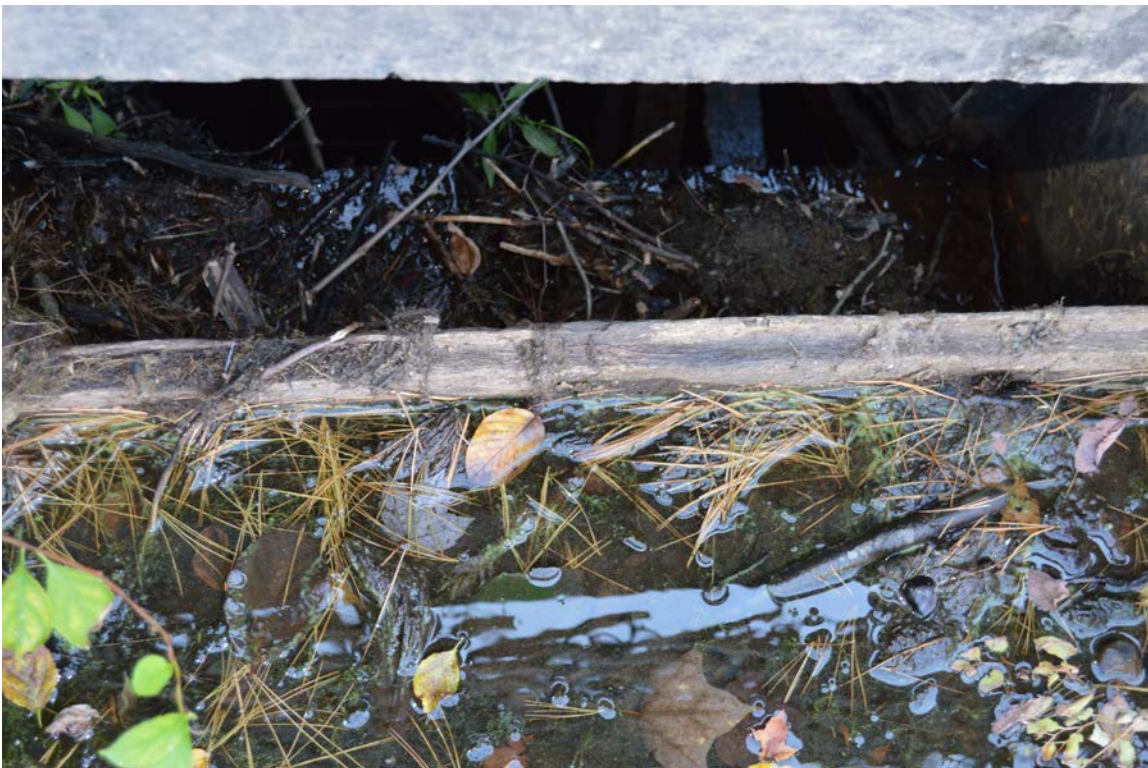
Other: The water level of the lake is controlled by the weir boards set along the face of the spillway opening, and notched in by steel pieces bolted to the concrete to create a channel. The top-most, exposed board is heavily weathered, and the boards appear to have been in their current position for an extended time period. The steel channel pieces are corroding.

Photo 13 – A close up view of the spillway weir inlet, with the top weir board visible across the center of the photo.

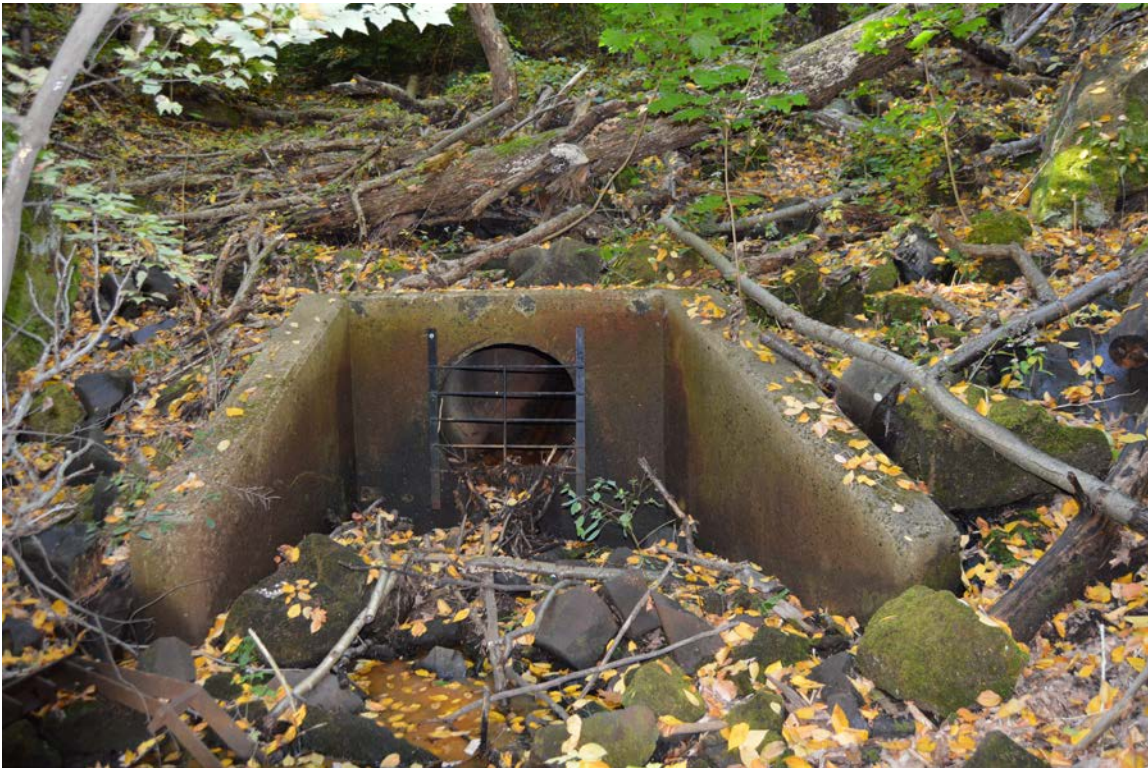
Photo 14 – The downstream outlet headwall and its adjacent stilling basin at the bottom of the photo. Riprap is still in place here, but there is a visible buildup of brush debris within the basin.

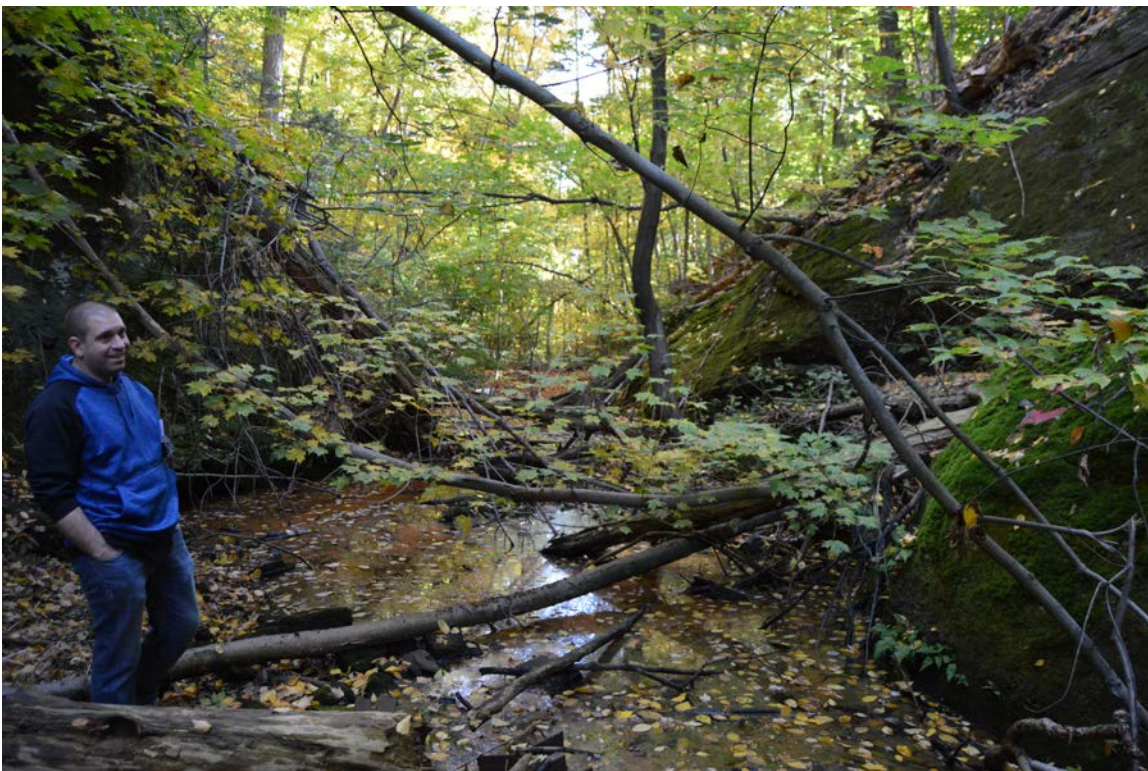
General Condition: Fair, based on the trees and brush growing on the sides of, and in some cases in, the stream. There is also significant debris (garbage, along with trees and tree branches) in the area immediately downstream of the outlet pipe discharge.

Photo 15 – Taken from the riprap stilling basin at the low level outlet discharge, looking downstream at Prout Brook. Trees are growing along and have fallen into the stream channel.

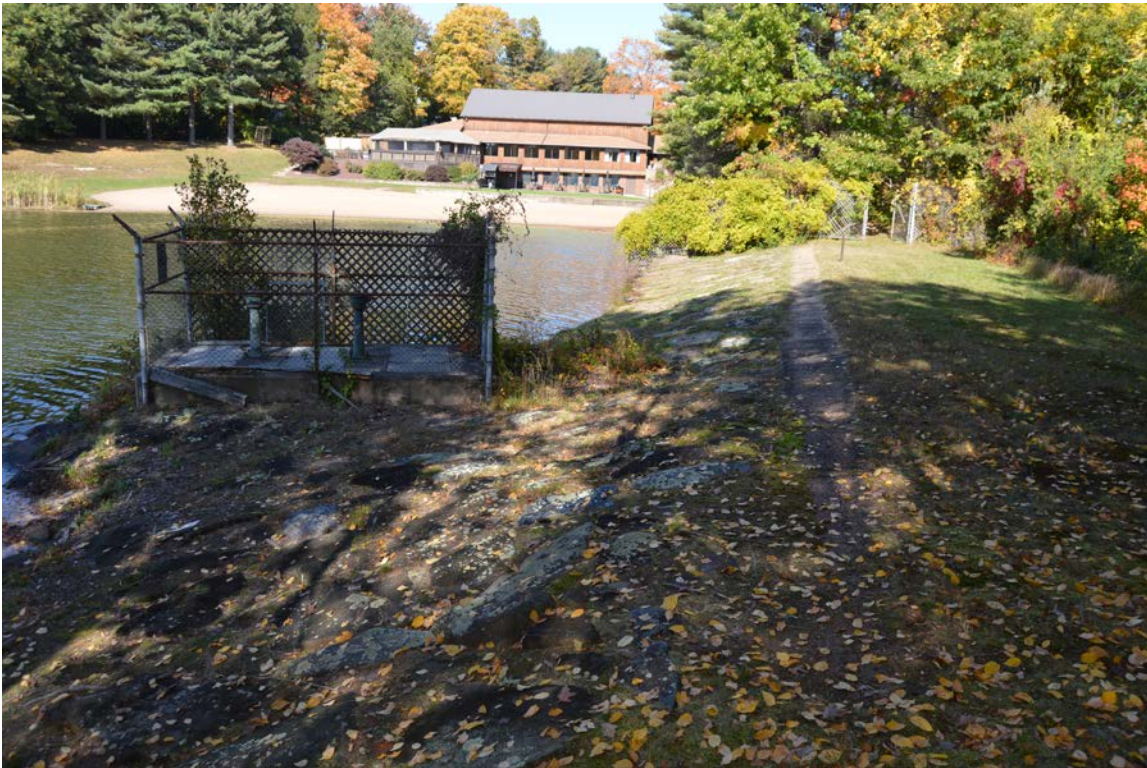
Photo 16a – A view of the water control structure from the right side of the dam. The two gate operators are visible in the center of the structure. Also note the high brush growth on the upper right edge of the photo – this area is the upper left end of the downstream embankment.

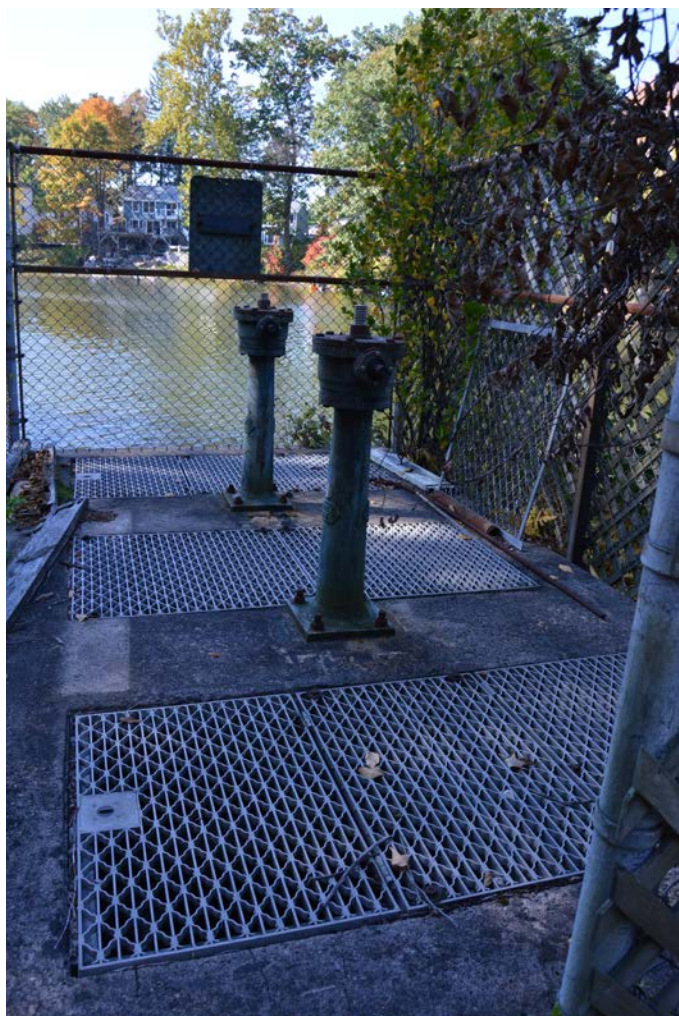
Photo 18a – Looking upstream at the two gate operators. Although not operated on the date of inspection, both appear to be in workable condition.

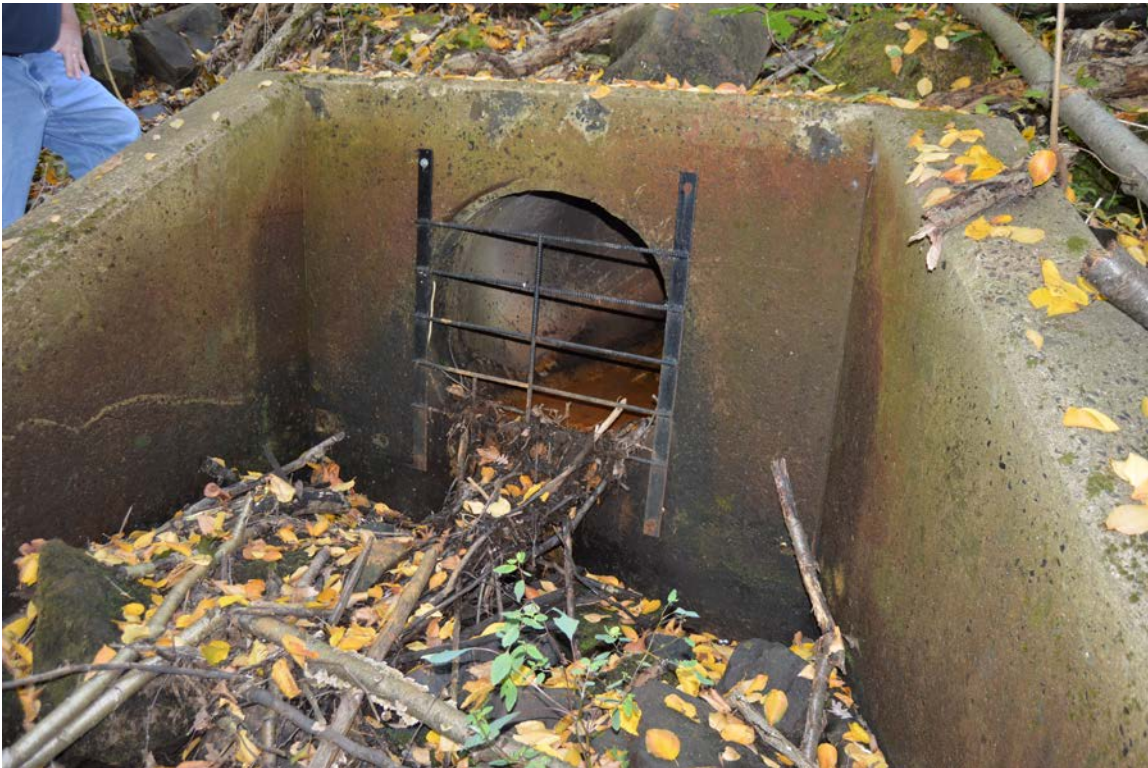
Other: As described in the history section, above, the original steel trash rack covering the pipe outlet became clogged by a combination of ice and debris in December of 2009, and was replaced by a new, much simpler rebar grid bolted directly to the concrete. This rack is in good condition.

The 36" RCP outlet pipe, to the extent that it can be seen from its downstream outlet, appears to be in sound condition.

Photo 19b – Another, closer view of the pipe outlet and headwall. The pipe is in good condition, as is the trash rack covering the opening.

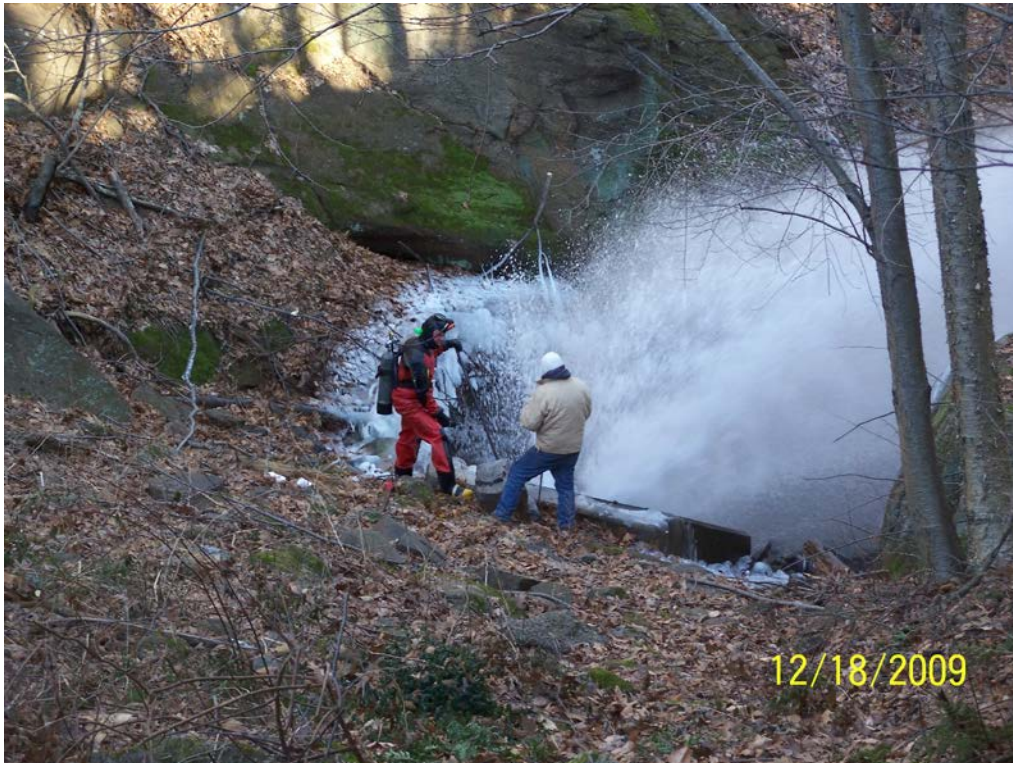
Photo 19d – Taken in December 2009, this photo shows the spectacle caused when debris plugging the old trash rack at the pipe discharge was cleared and flow subsequently released. The debris had frozen in place, forming an ice blockage and completely impeding flow through the low level outlet pipe. The rack had to be cut off with power saws and cutting torches, and was then replaced by the current rebar grate.

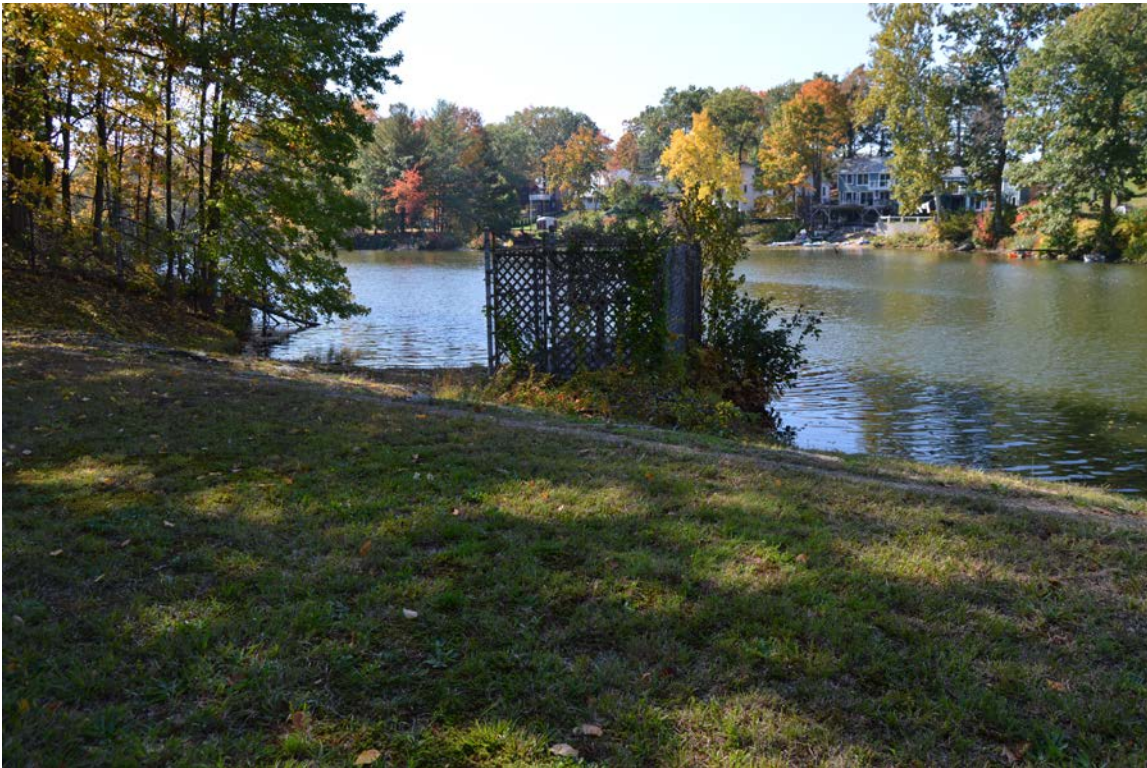
Photo 21a – Looking upstream from the crest of the dam toward the water control structure. The brush and vines growing near the structure and on the fencing needs to be removed. This is a perpetual problem.

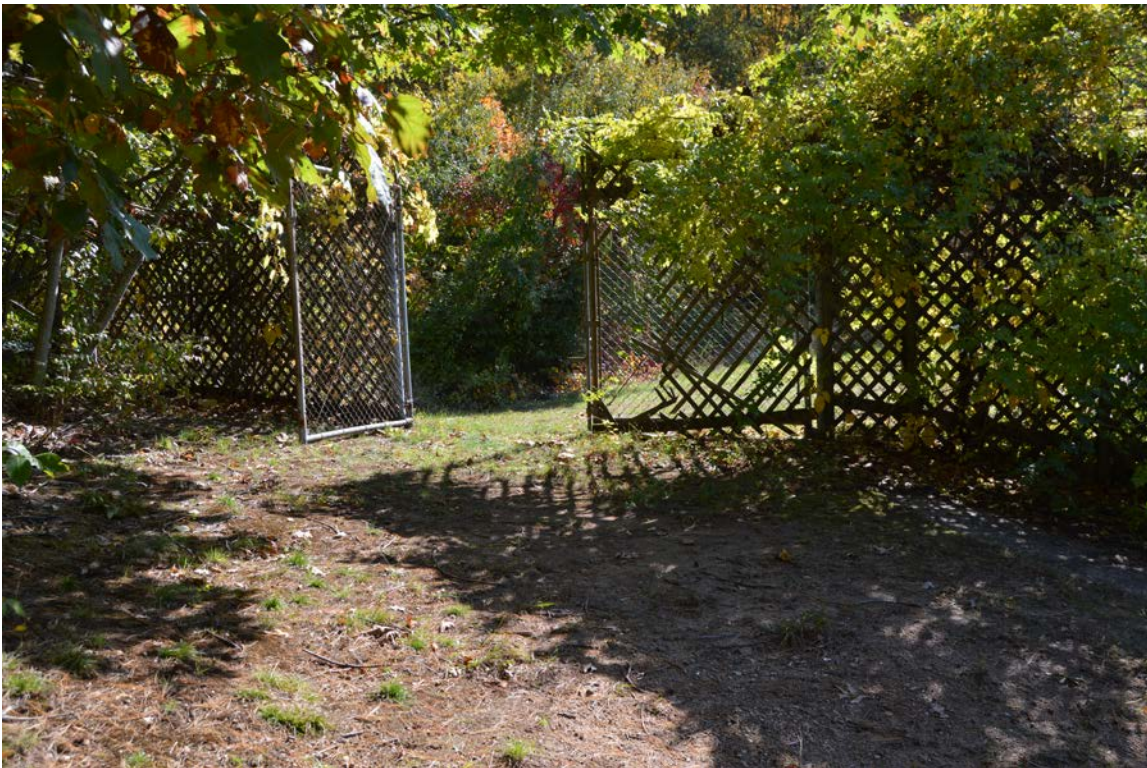
Photo 21b – View of more brush growth to be removed, this time at the left abutment, and looking straight through the open gate to large-scale growth on the downstream earth embankment.

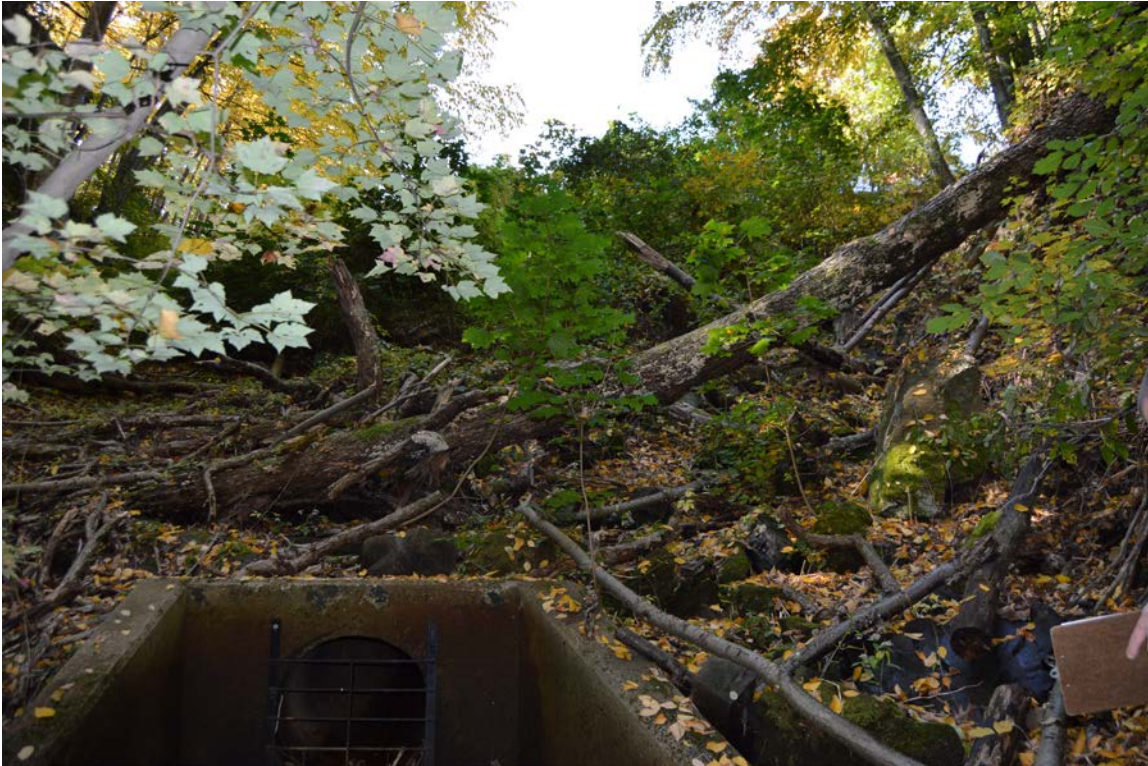
General Condition: The downstream slope is in poor condition. It is not currently showing signs of instability, but is entirely covered by small trees, brush and woody vegetation growing adjacent to and up through the ungrouted riprap. The density of the vegetation is such that walking down the slope during the peak growth season would be difficult. The crest and upstream slope are in generally good condition, with grass maintained and only minor maintenance issues present.

Photo 21c – An overview of the downstream embankment as seen from its toe, showing an array of vegetation – brush, vines, trees and debris – present along the slope.

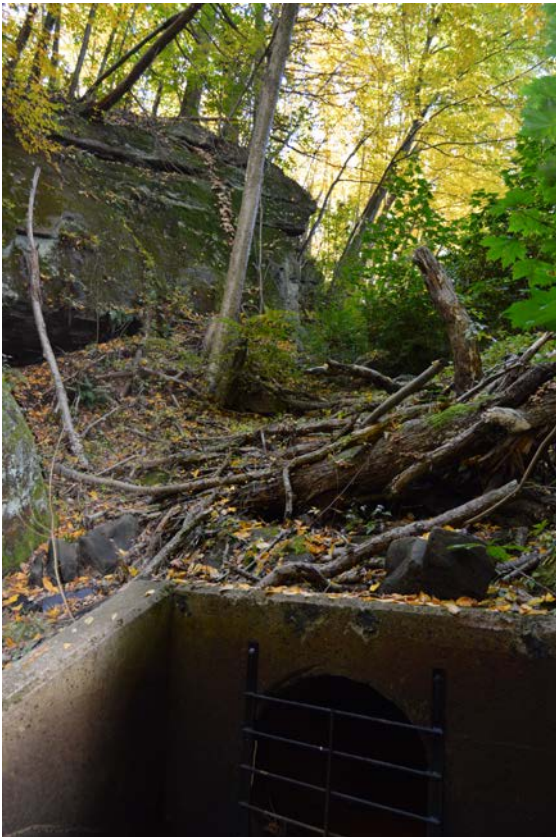
General Condition: Fair. The condition of the walls is currently stable, but shows signs of minor spalling along the top.

Photo 21d – Deterioration along the top of the downstream concrete headwall. Another view of trees growing along the embankment is also seen in the background.

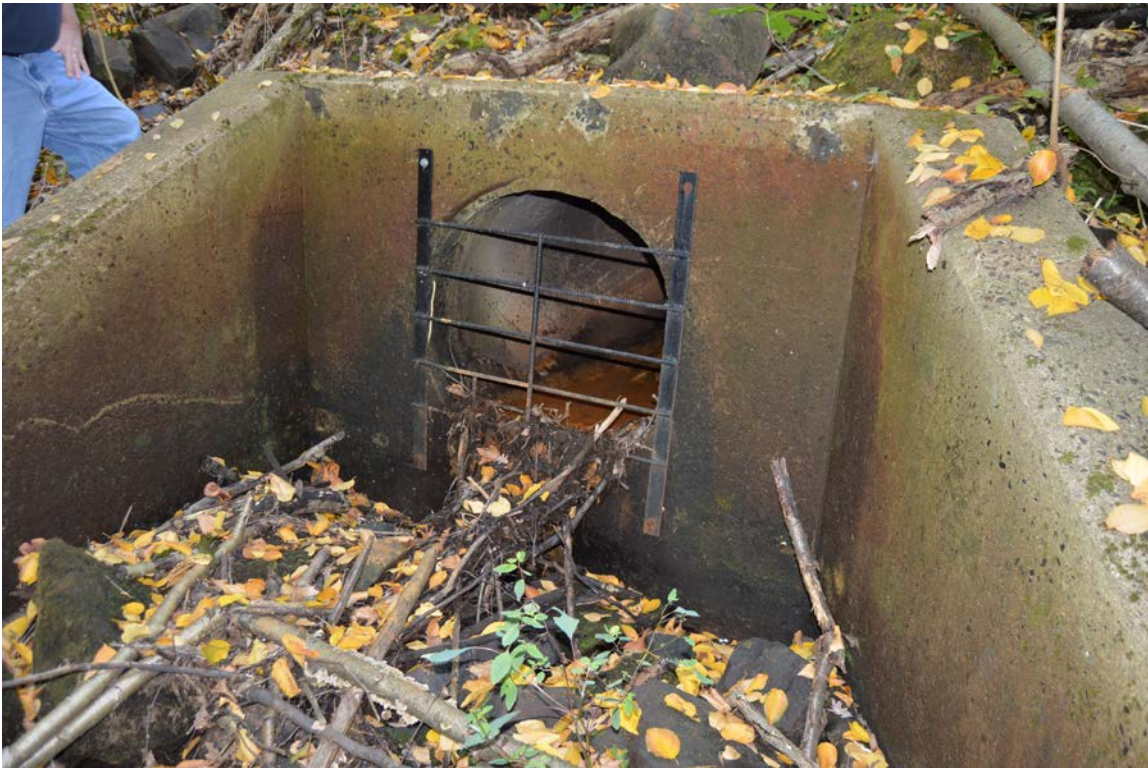
Concrete Condition: While presently stable, the concrete wall sections have minor chipping and spalling over a portion of the top and upper sections.

Photo 21e – A close up of the downstream headwall, showing spalling along the top of the wall.

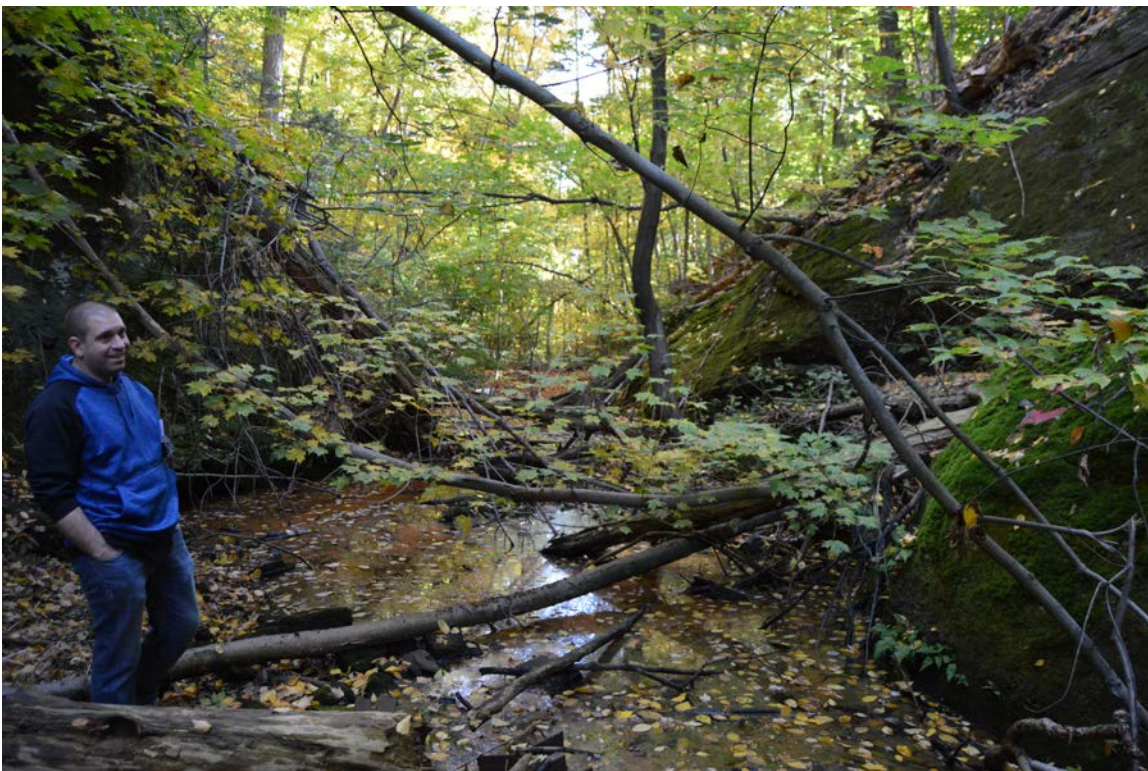
Photo 21f – As with other areas, the downstream channel is clogged with trees, brush and debris.

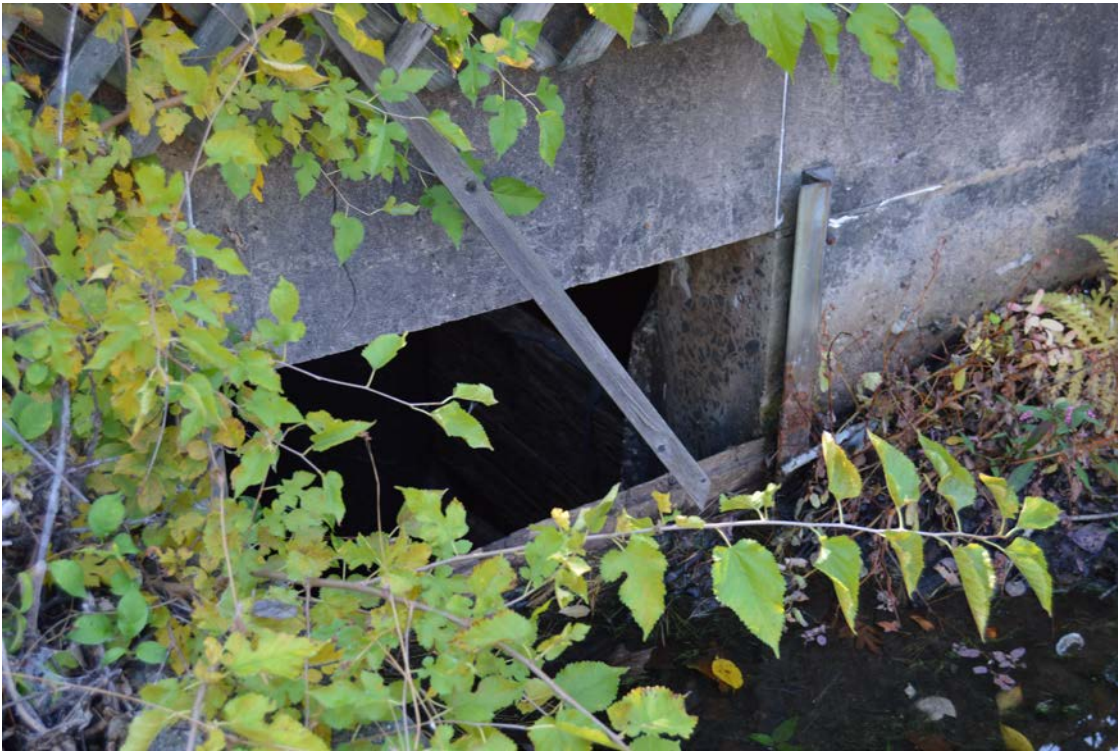
Concrete Condition: The concrete at the left side spillway opening is in fair condition, with several chipped and spalled sections. On the interior part of the right side wall opening, the wall had chipped away to the extent that rebar was exposed (and had begun to corrode). The concrete and rebar issues may be related to the cut into this existing concrete wall section to create a new opening as shown on the as-built plans of 1990.

Photo 21g – A close-up view of the drop inlet spillway entrance. Several problems can be noted, included deteriorated weir boards, vegetative growth, deterioration of the concrete (exposed rebar is visible behind the diagonal piece of wood), sediment build up at the weir boards, and corrosion along the weir board channels.

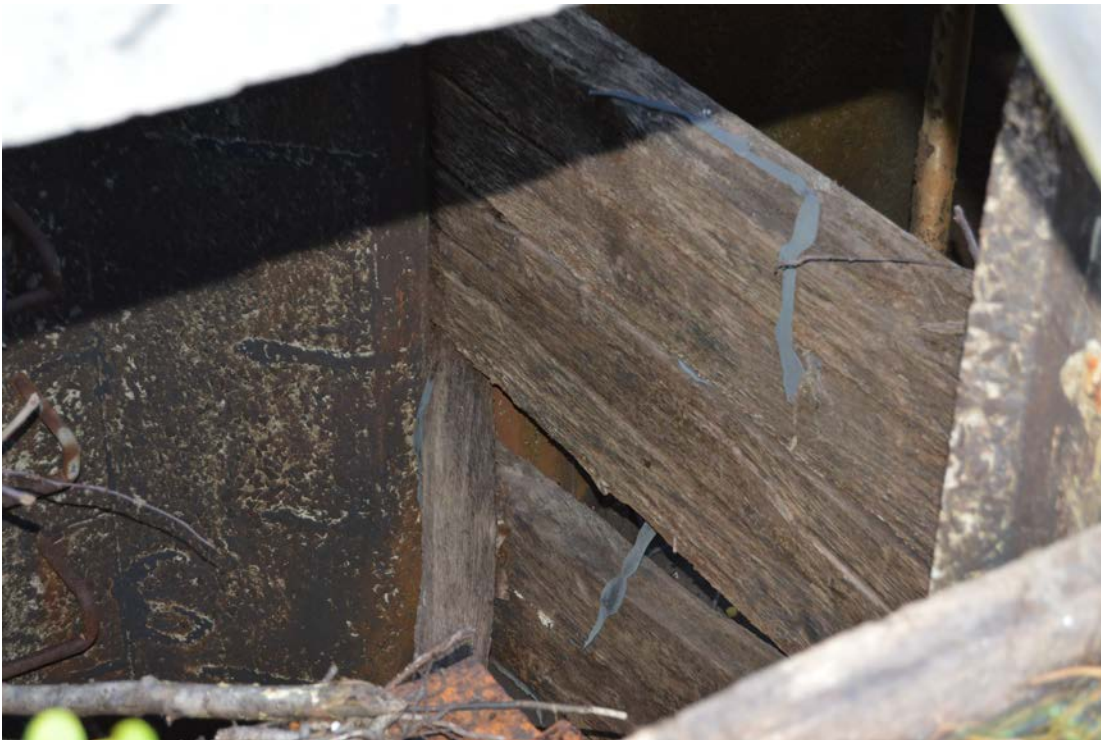
General Condition: Fair. Many of the structure's constituent parts are worn or deteriorated. The stop-logs set in the interior that were visible above water were disintegrating and in a deteriorated state. The condition of the sluice gates and stems could not be ascertained, but were known to have been operated in the past; the gate operators appeared to be in good condition, but should be operated in the near future (see Recommendations, below). The steel grates are in fair to good condition – the grates themselves are generally in good shape, but the bolts attaching them to the concrete are corroded. The gate operating or hoisting mechanisms are in a similar state, with corrosion noted on bolts and covers, but the main functional parts of the mechanisms are, however, in generally good condition.

Other: There are 4 sets of steel ladder rungs leading down from the top of the structure to the interior base; the portions that were visible on the date of inspection appeared to be corroded, and untrustworthy for use.

Photo 21h – Looking at the interior of the intake structure. Wood boards separating the interior sections of the structure have deteriorated. On the left of the photo, the steps leading down to the base of the structure are corroding.
